CERTIFICATION OF MEASUREMENT

MRS-6XY-3-038

MRS-6 Magnification Reference Standard

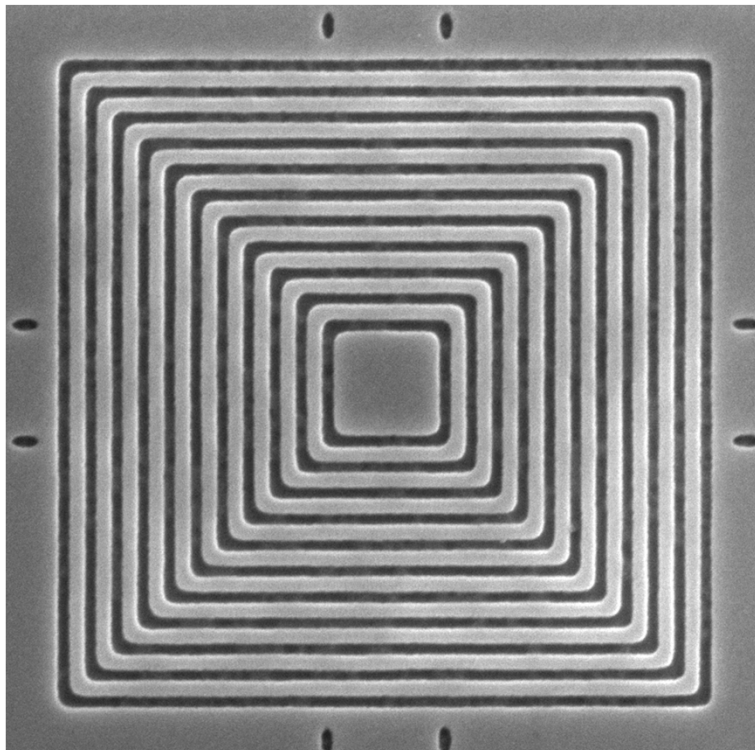
100nm Pitch Pattern of
MRS-6XY-3-038
Pattern #1

All measurements are performed in vacuum with a field-emission SEM. The traceable 2µm, 1µm and 100nm pitch measurements are made between the horizontal and vertical tracks through the center of the pattern. There are four 100nm patterns; measurements are made through the center of one of those patterns the number of which is next to the micrograph on the certification. For each pattern, horizontal measurements start at the left edge of the first bar on the left, proceeding toward the center, then from the right edge of the first bar on the right side of the center, continuing to the right. The vertical measurements are made the same way starting at the top of each pattern. The value for each pitch is the average of approximately 100 scan lines between the tracks. Measurements are made through direct comparison with a MRS that has been measured by the National Physical Laboratory (NIST counterpart in the U.K.) using a calibrated atomic force microscope (AFM) with a sharpened tip, thereby establishing an unbroken link of traceability. Each measurement is reported as a "pitch" value, which is the sum of an adjacent bar and space (edge-to-edge) on the pattern. For the 100nm pattern, edge-to-edge pitches are traced to a mean peak-to-peak value established by NPL. The standard was measured in vacuum. For usage: 25°C ± 10°C, humidity <90%.
